EPIDEMIOLOGIC

INVESTIGATION

REPORT

The complainant alleges that her battery operated smoke detector must have had a malfunction, as her son found that flames were coming from this smoke detector. The son grabbed the smoke detector and ripped it off of the wall, and then threw it into the toilet. There was only minor smoke damage to the wall in the hall of this home, and no one was injured in this fire incident.

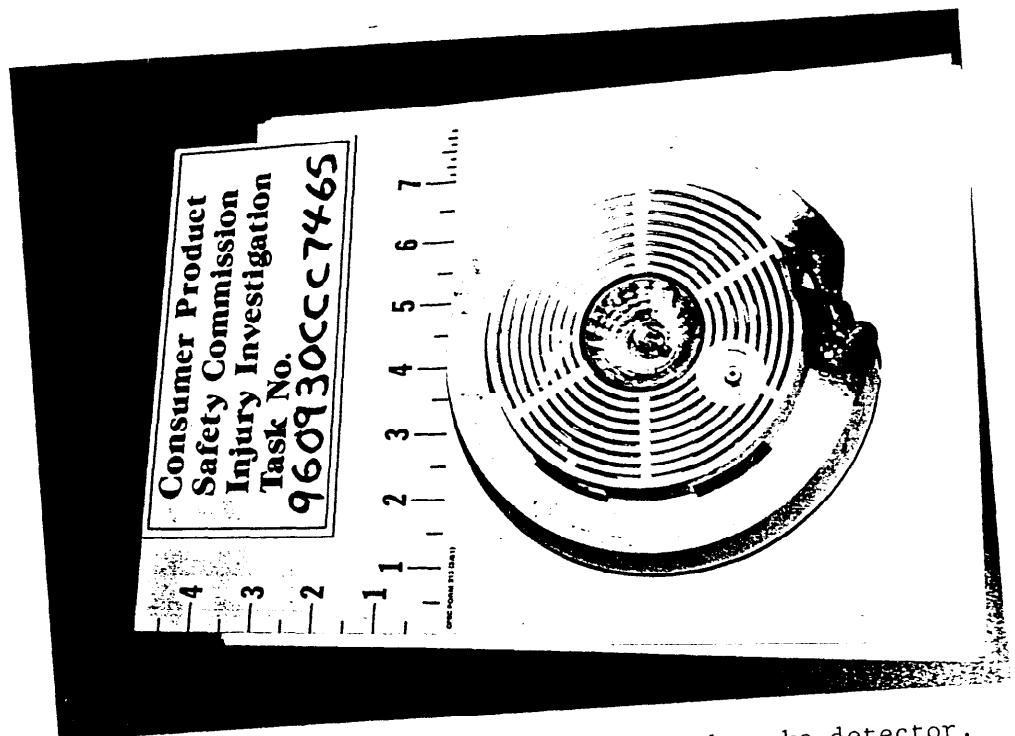
PHOTO #6: Photograph of the fire damaged smoke detector. This is a photograph of the smoke detector's front cover.

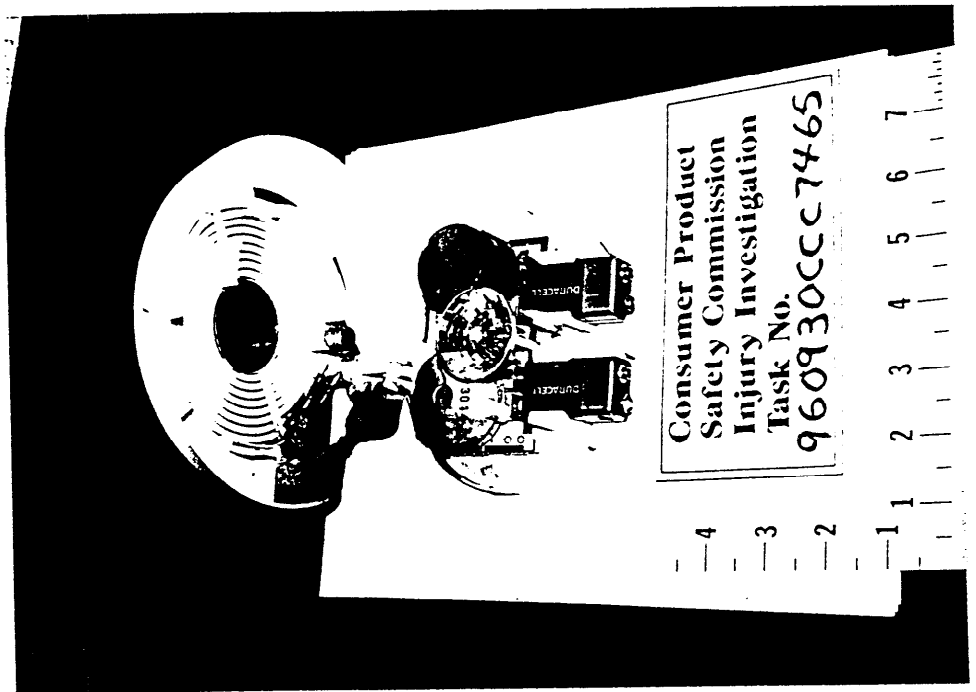
PHOTO #8: Photograph of the smoke detector, with the cover raised. The consumer reports that the batteries were disconnected (after the fire) and set back the battery compartments the opposite direction.
